D4.3 PILOT PROJECT APPLICATION REPORT LATVIA

PILOT PROJECT – EPC FOR APARMENT BUILDING IN BERZUPES STREET 23

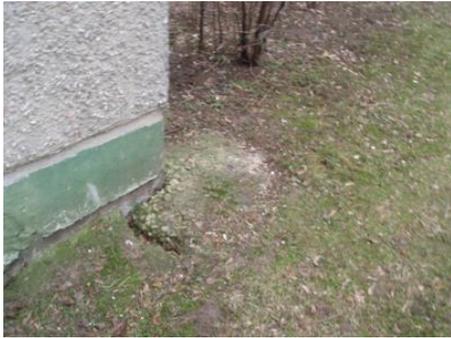
Damaged building plinth

2. Foundation insulation:
 - a. An existing concrete border was dismantled along the perimeter of the building, and the front stoves at the entrance knots. The existing damaged plaster was repaired, and the surface was smoothed.

- b. For the surface part of the cap, and for the part of the base below the ground level ~ 1.0 m, the vertical waterproofing was incorporated into the depth of 2 layers and insulated with EPS plates at a thickness of 50 mm along the whole perimeter of the building. Front plates were attached to the finishing with glue.

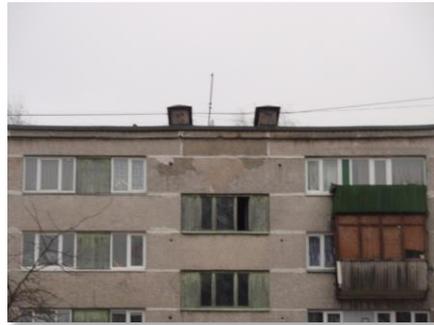
Damaged facade and cap fittings

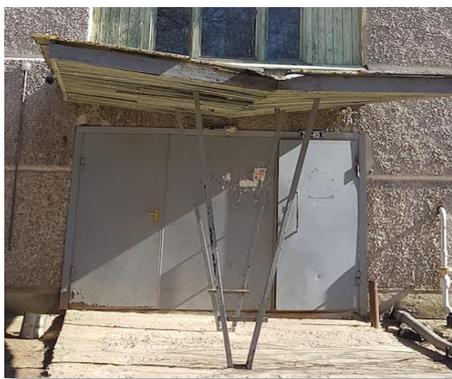
- Outside the entrances to the building are rooftops made of steel structures. The roof is formed in the form of "v" with the rain water collection part in the centre. The roof is composed of asbestos-cement sheet material on top and a tin covering under.

Entrance rooftops

6. Reinstatement of entry roofs:
 - a. The entrance rooftops that was in poor technical condition and their supporting columns were dismantled. Instead, lightweight metal roofs were installed, which were constructed from carrying profiles. Roof covering galvanised and dyed sheets of profiles.

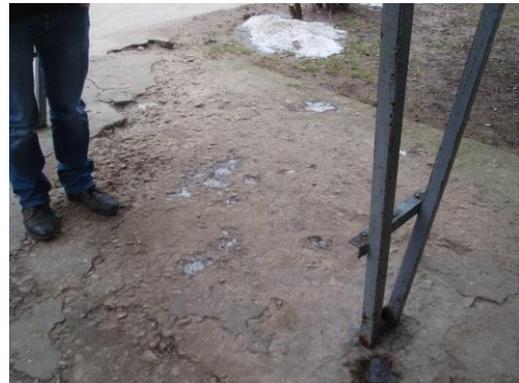
- The entrance porches for the building are made of concrete. The concrete is mossy and with local salt discharge. There is concrete corrosion on the sides of the porches.

Entrance monolithic concrete damaged

- c. A concrete cobblestone protector border was constructed around the perimeter of the building. The porches were restored with replacement mortar composition.

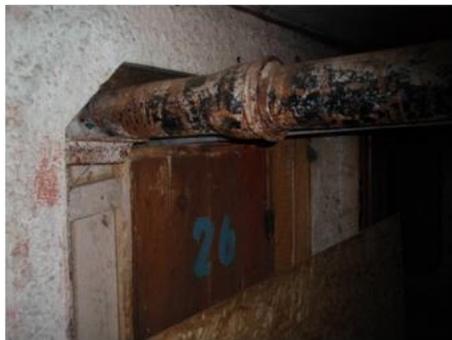
Sewer output from the building

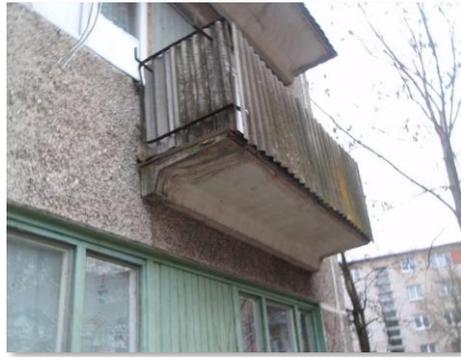
The lower surfaces of the boards of the balconies have been damaged, the colouring has been removed, the collared mesh has been damaged and the reinforcement has been exposed. The steel elements of the manila railings have fallen, the railing lining has worn off. The concrete layer of the surface of the balcony plates is relaxed and crumbled in places, finishing sheets worn out.

- d. Restoration of the balcony, restoring its waterproofing, finish, and removal of old fills from the balcony railing, cleaning the railings from corrosion, treating with anti-corrosion products, painting. Reinstating welds if necessary.
