D4.3 PILOT PROJECT APPLICATION REPORT LATVIA

PILOT PROJECT – EPC FOR APARTMENT BUILDING IN BERZUPES STREET 23

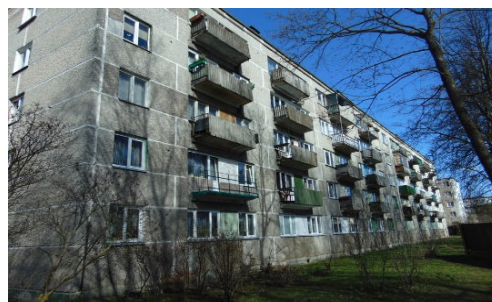
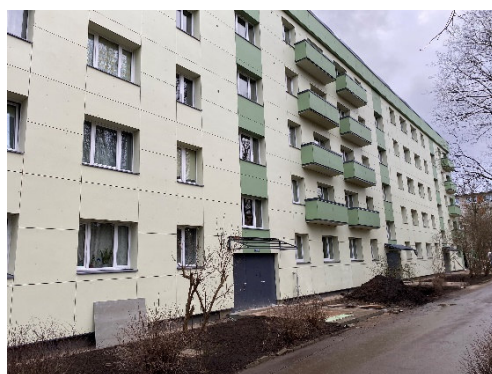
- Renovation of the ventilation system;
 - Replacement of the heating system, with new radiators and thermostats;
 - Replacement of the hot water system.

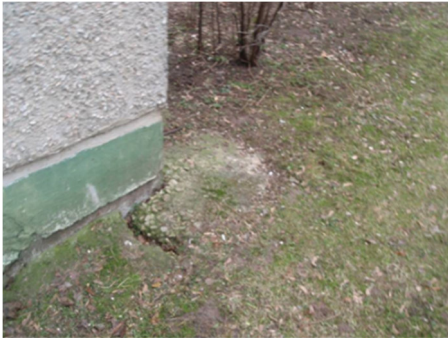
Damaged building plinth

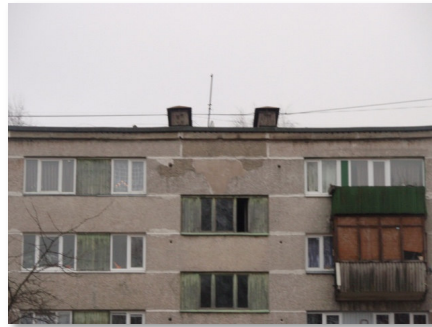
Damaged facade and cap fittings

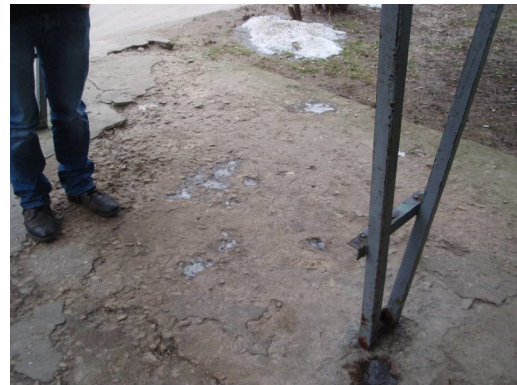
Entrance monolithic concrete damaged

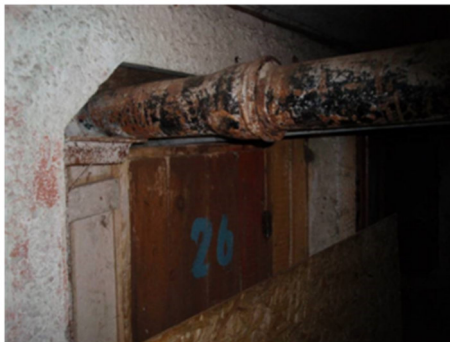
Sewer output from the building

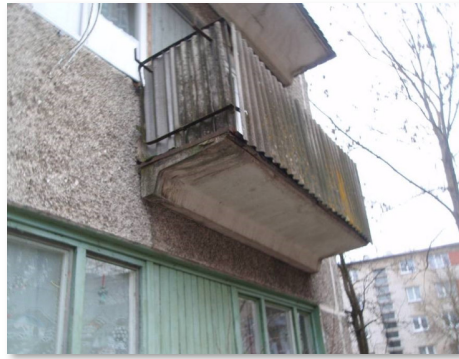
Ventilation shafts and canals. The ventilation channels have not been cleaned. The outlets on the roof are made from the exposed clay bricks and are covered with tin made rooftops. As a result of external rainfall, the housing of the venting channels has fallen and continues to deteriorate. The damaged areas need to be cleaned and sealed.

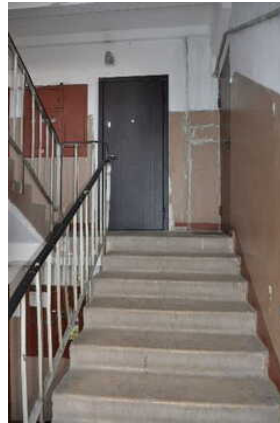
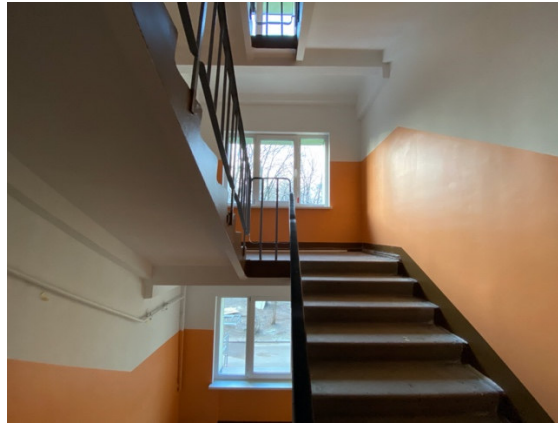
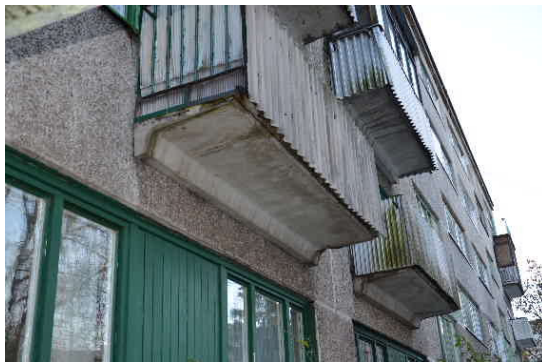
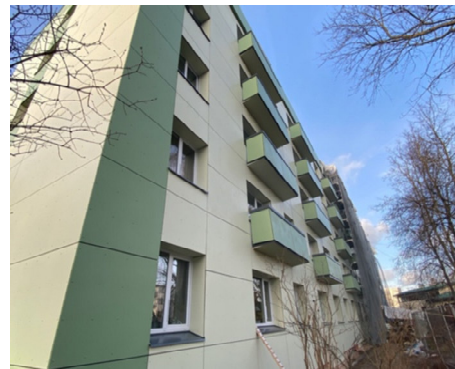
Thermal energy consumption before –
191, 1 kWh/m² year.

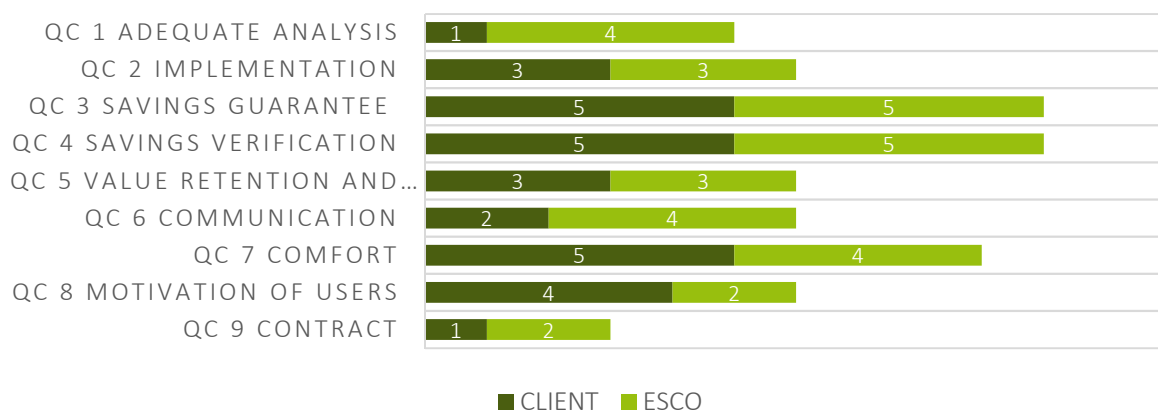
3.3 How easy is it to provide evidence?

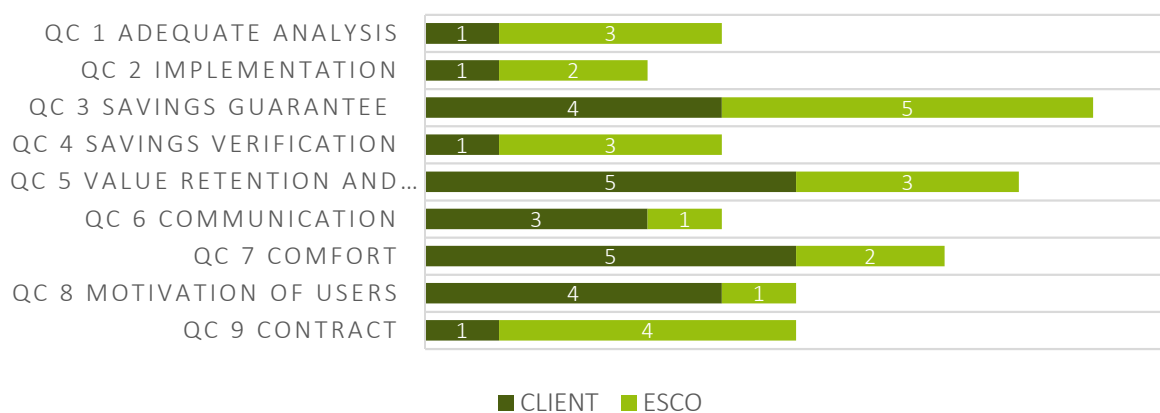
3.5 Barriers and success factors for the application of criteria
